# Influence of human activities and climatic change on permafrost at construction sites in Zermatt, Swiss Alps

Rüdiger HOF, Lorenz KING & Thomas HERZ (*Institute for Geography, Justus Liebig University, Giessen, Germany*)  
Stephan GRUBER (*Geographical Institute, University of Zurich, Switzerland*)

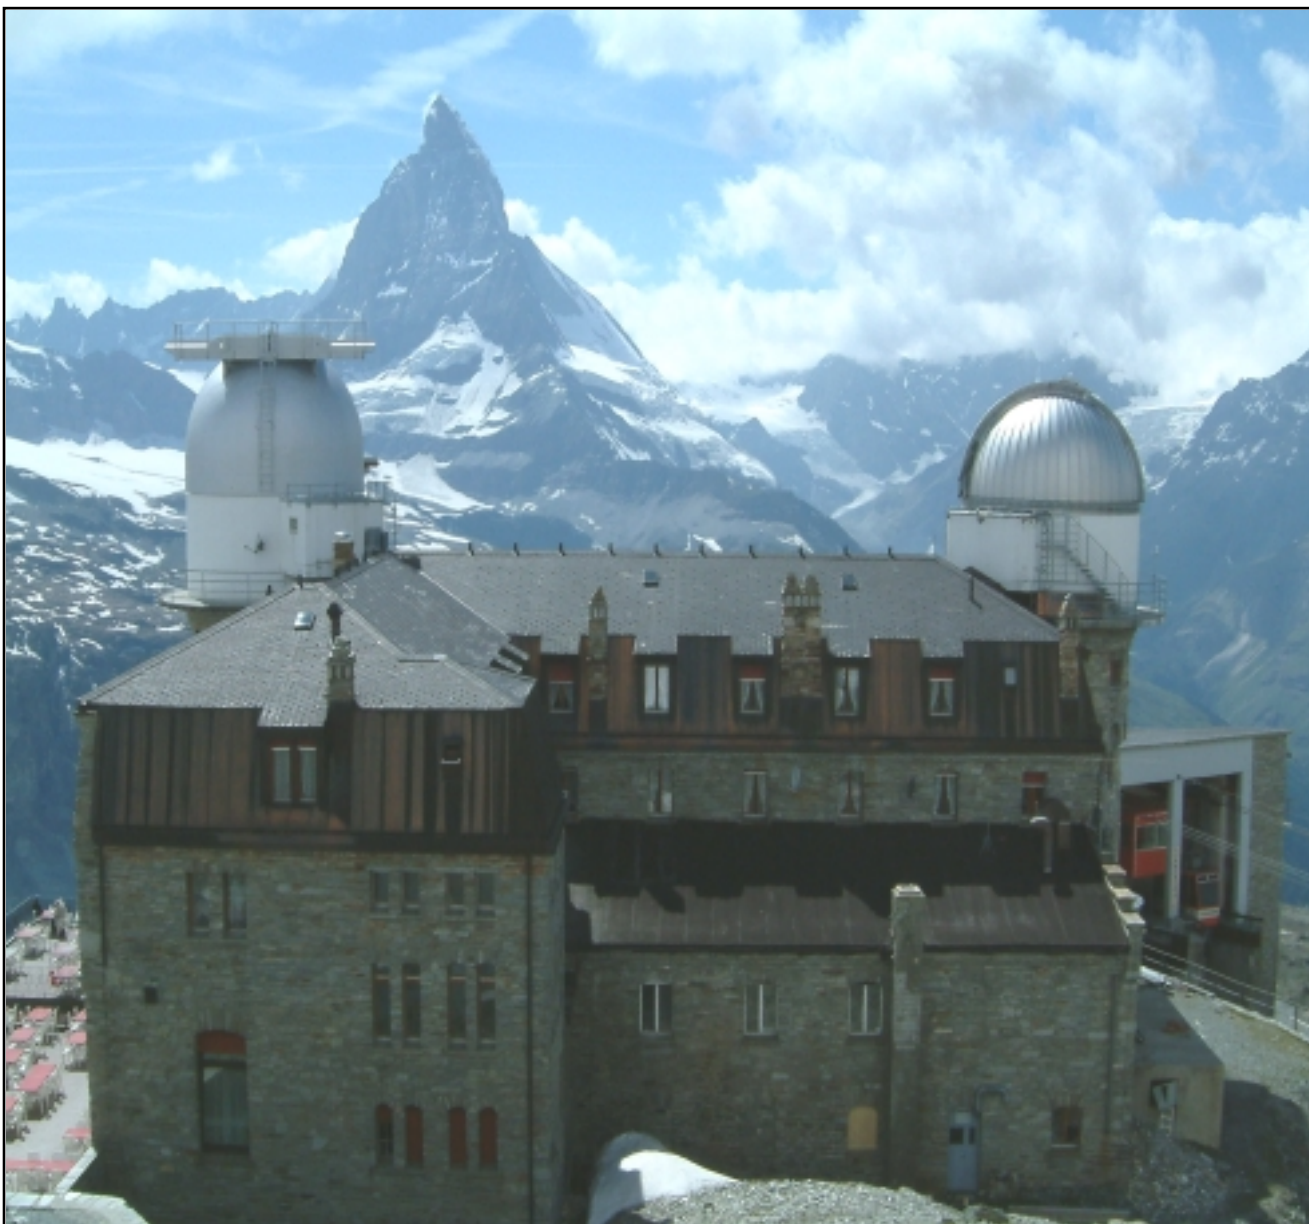
Figure 1: View towards the Gornergrat Kulmhotel with the observatories in the northern (right) and southern tower (left). The prominent peak of Matterhorn (4478 m a.s.l.) is seen in the background

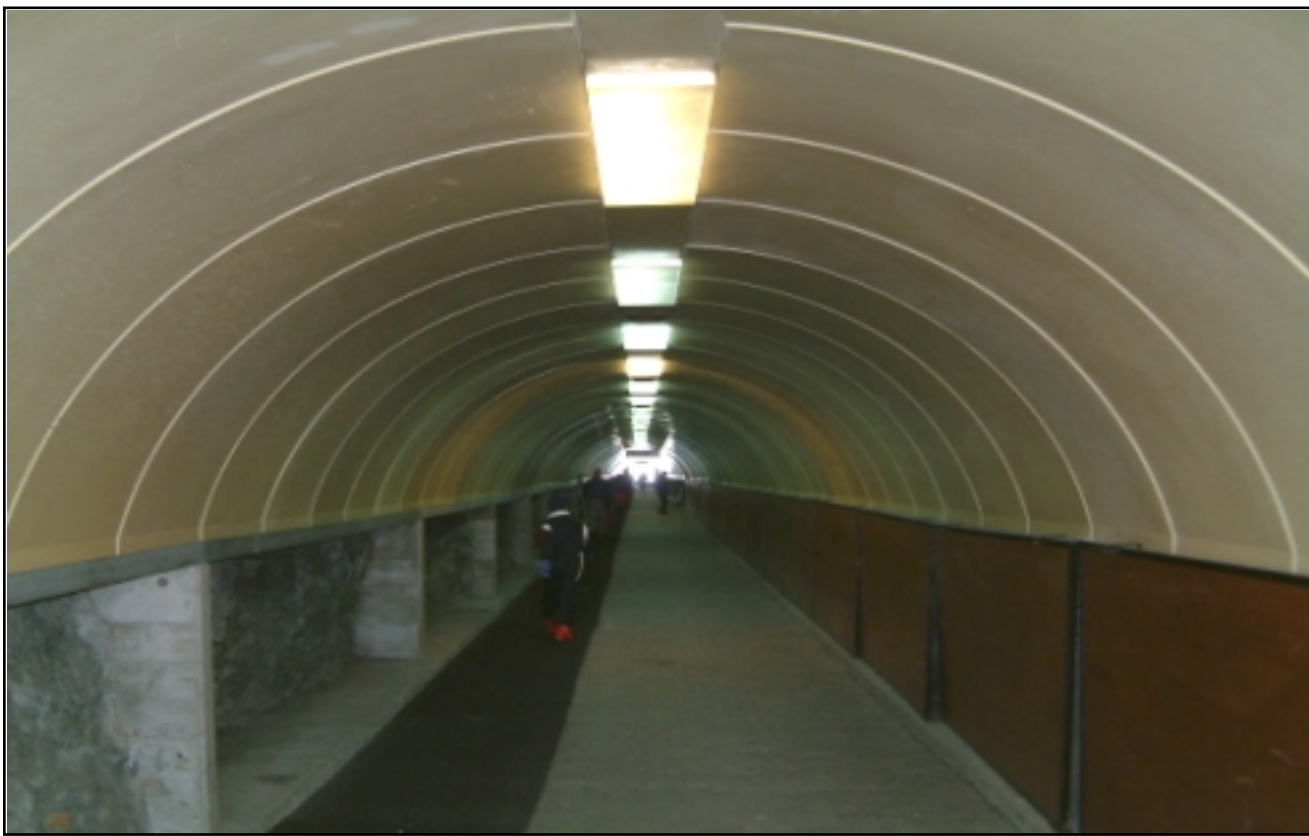
Figure 5: View into the tunnel across the peak of Kleinmatterhorn (3820 m a.s.l.)

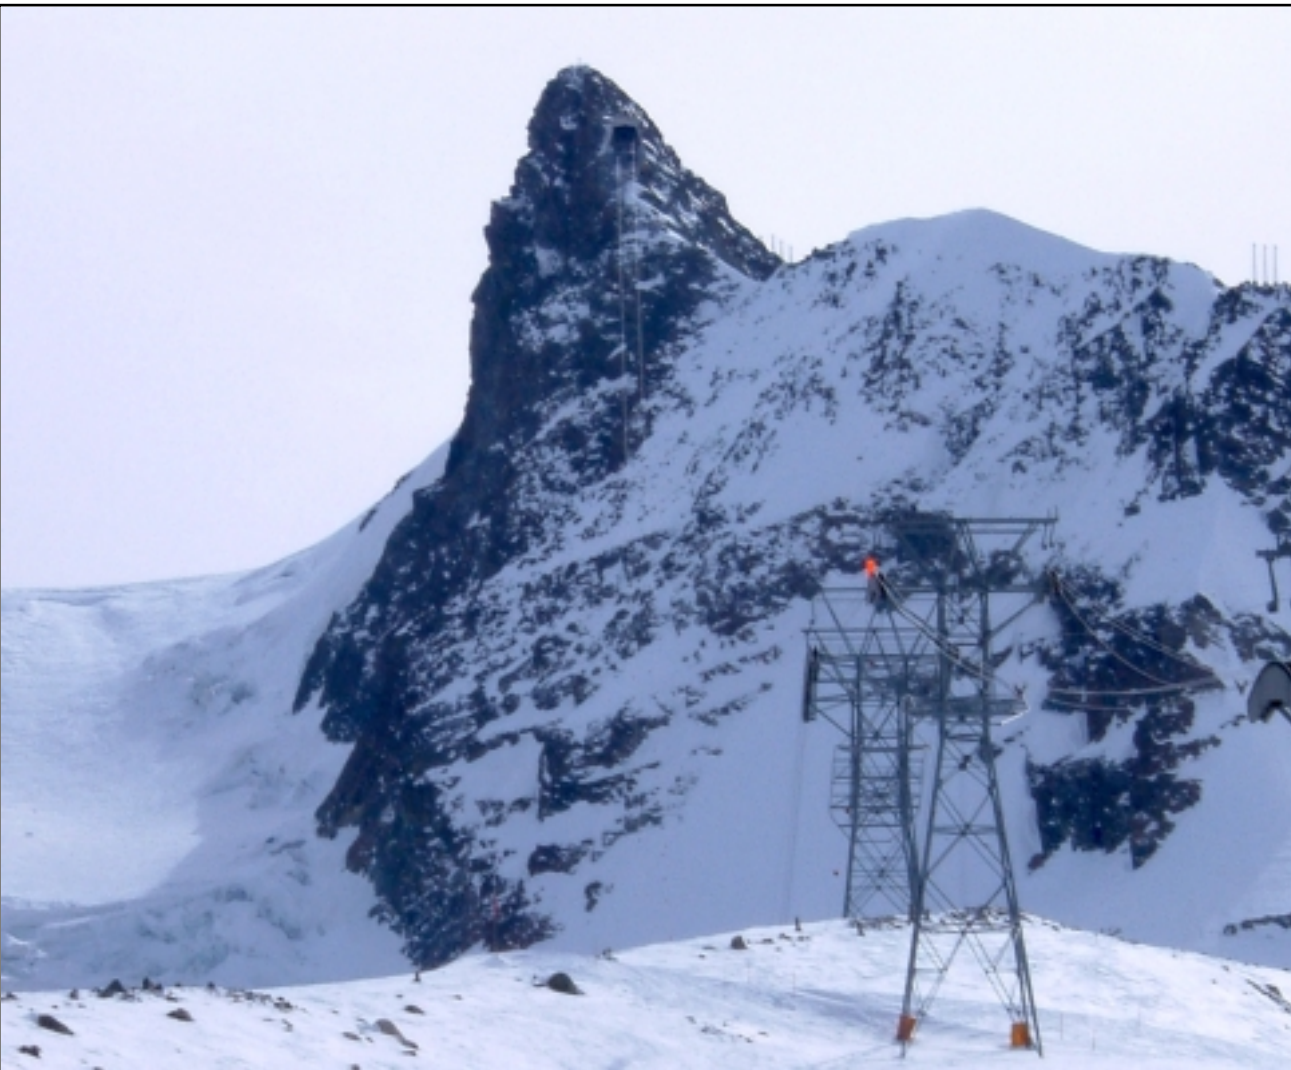
Figure 6: Kleinmatterhorn (3883 m a.s.l.) with funicular pylons (3012 m / 3025 m a.s.l.)
